BAE study evaluates impact of cattle grazing on stream bank erosion

The goal of this project is to provide the agricultural community with a better understanding of the impacts of cattle grazing on stream bank erosion, and to improve current cattle production practices on small farms in Kentucky. Common with SARE's goal, this project seeks to strengthen the agricultural competitiveness of Kentucky's cattle producers while conserving soil, water and stream habitats. It is important to note that this project is a subset of a larger research endeavor into grazing impacts of cattle and best management practices (BMPs) on the water quality of a Kentucky stream. Information regarding the overall research effort can be obtained at the following website: www.bae.uky.edu/WQ406.

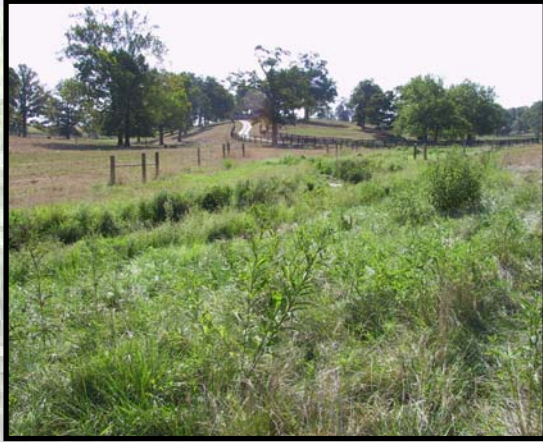
Limited access, alternate water source

Data analysis techniques are still being evaluated, but preliminary results suggest that the treatment marked by limited access has gained soil while both unlimited access treatments have experienced erosion. Photographic documentation also suggests that greater erosion rates are being seen in the unlimited access treatments. Statistical models are being developed to determine the effects of different grazing practices and BMPs on stream bank erosion.

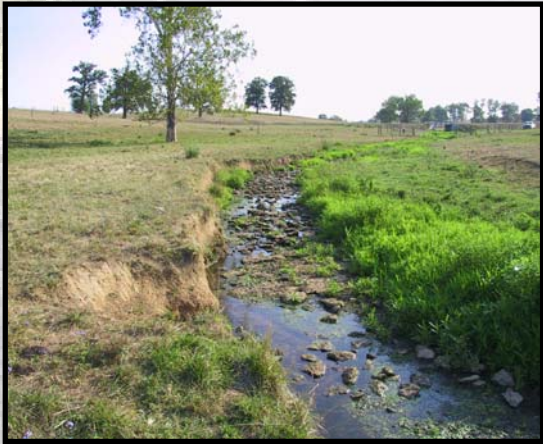
Unlimited access, alternate water source

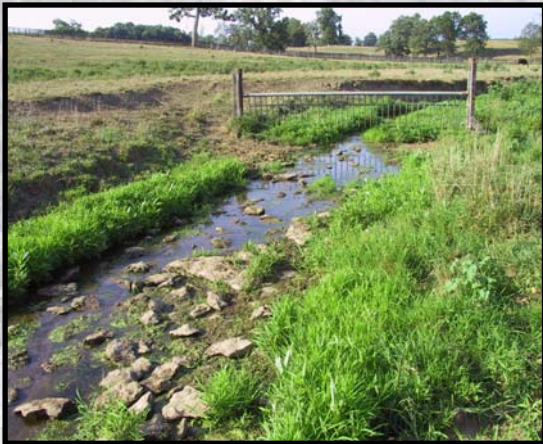
Unlimited access, no alternate water source
